**Site Investigation No. AE0709
Piling Risk Assessment**

**Proposed Training Facility
Cardiff Docks**

October 2016

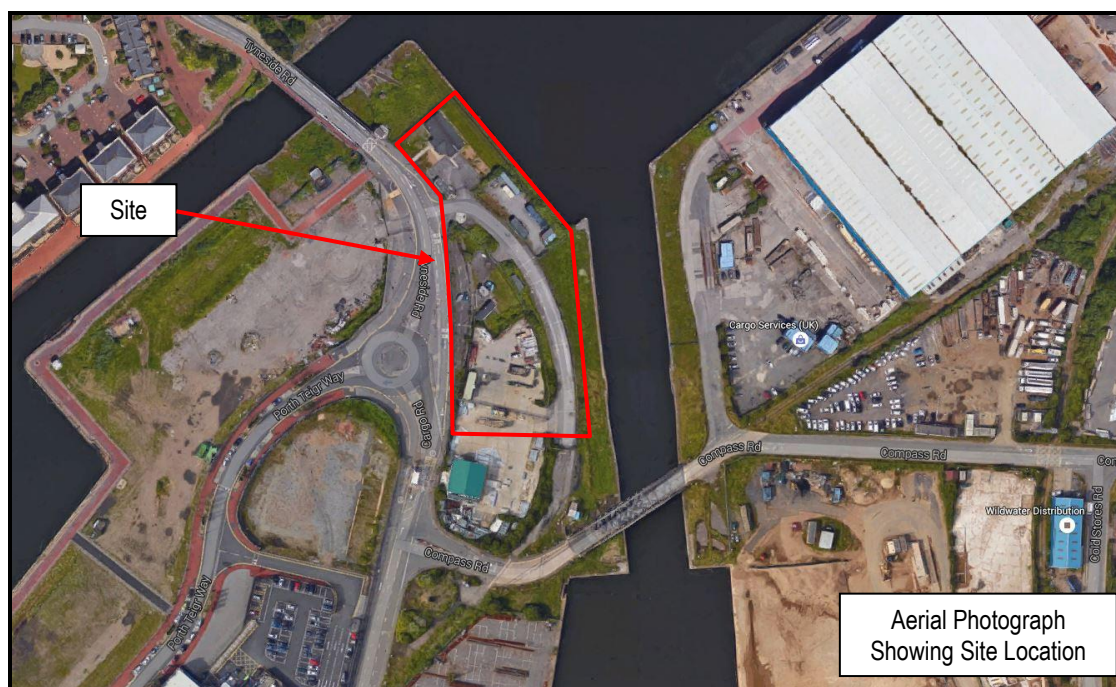
The site is located within Cardiff Docks at National Grid Reference ST 199 745, and is shown on the Site Location Plan, included in the Appendices to this report and in the aerial photograph below.

The site is irregular in plan shape and is bounded to the north and east by waterways associated with the docks and to the south and west by Cargo Road and Compass Road, respectively. At the time of writing this report the site was occupied by buildings, hardstanding and soft landscaped areas. The northern area of the site appeared to be disused with the remainder of the site occupied by buildings associated with County Marquees, Fuel Centre and Maritime Volunteers Centre. There is a 'tank' located in the Maritime Volunteers Centre.
